ELLIS ISLAND, NEW IMMIGRATION BUILDING  
(U.S. Immigration Station)  
Statue of Liberty National Monument  
New York Harbor  
New York  
New York County  
New York

HABS NY-6086-O  
NY-6086-O

HISTORIC AMERICAN BUILDINGS SURVEY  
ELLIS ISLAND, NEW IMMIGRATION BUILDING

HABS No. NY-6086-O

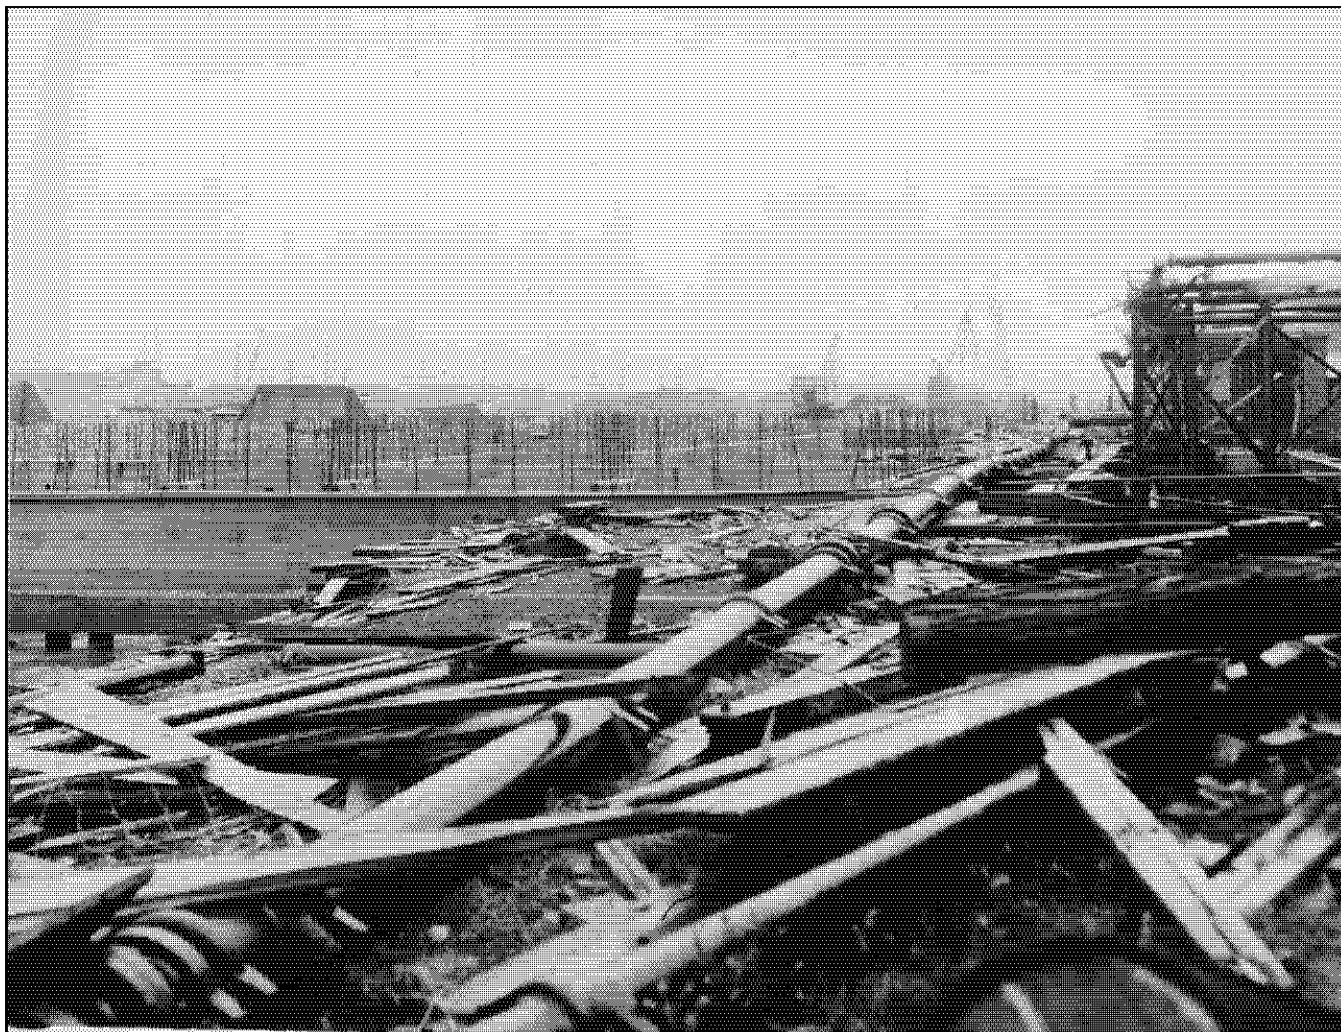
Figure 5: Foundations for New Immigration Building, 1 December 1934

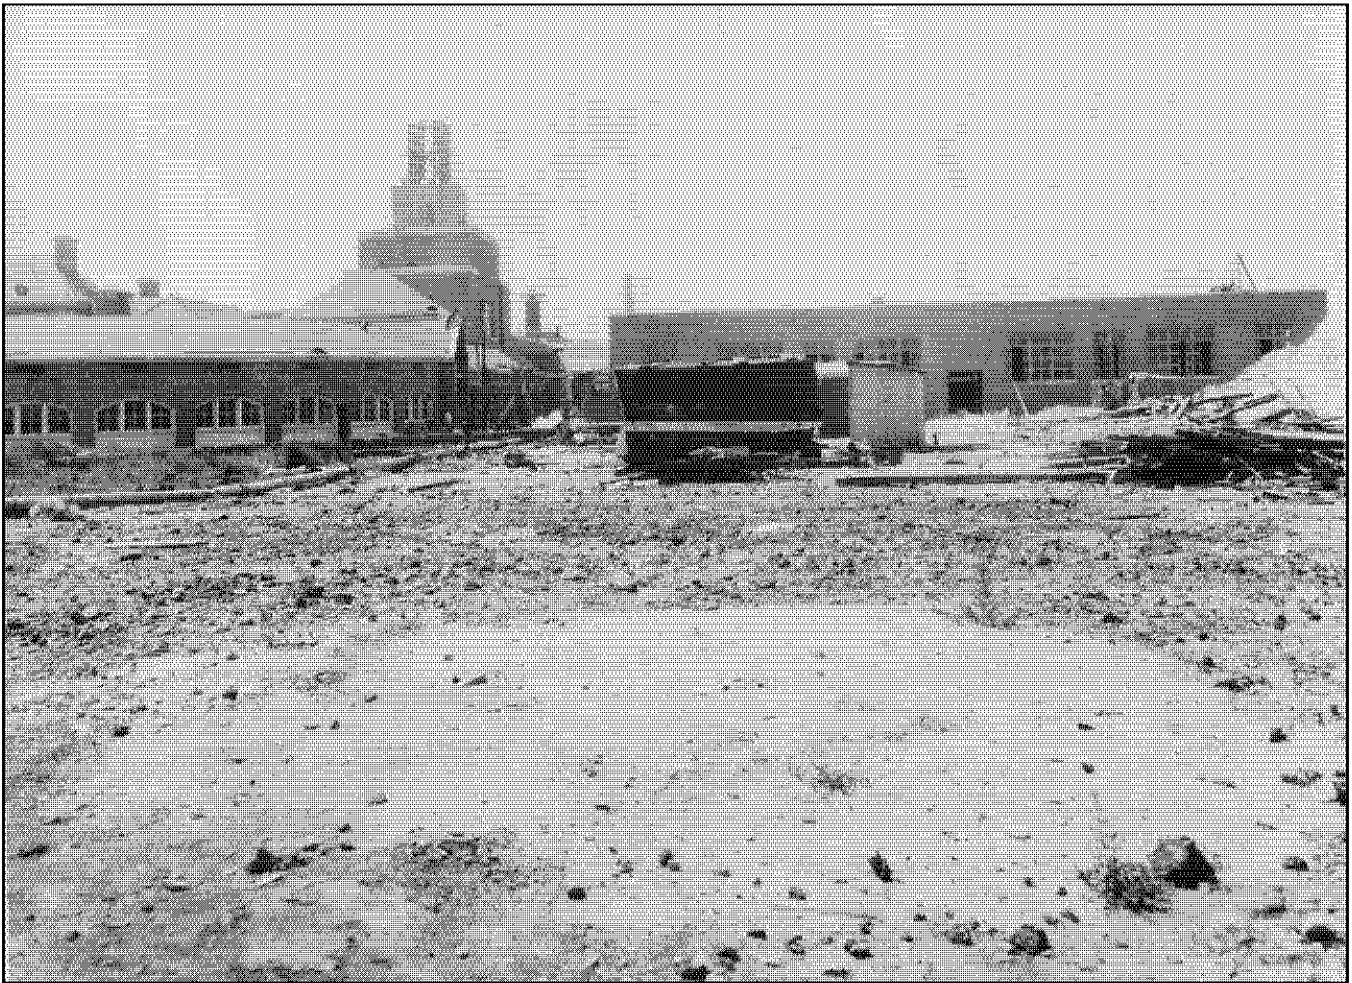
Figure 6: New Buildings, 26 August 1935,  
Source: Record Group 121-BCP – Records of the Public Building Service,  
Photographs of the Construction of Federal Buildings, 1885-1954,  
Still Picture Branch, National Archives and Records Administration, College Park, Maryland

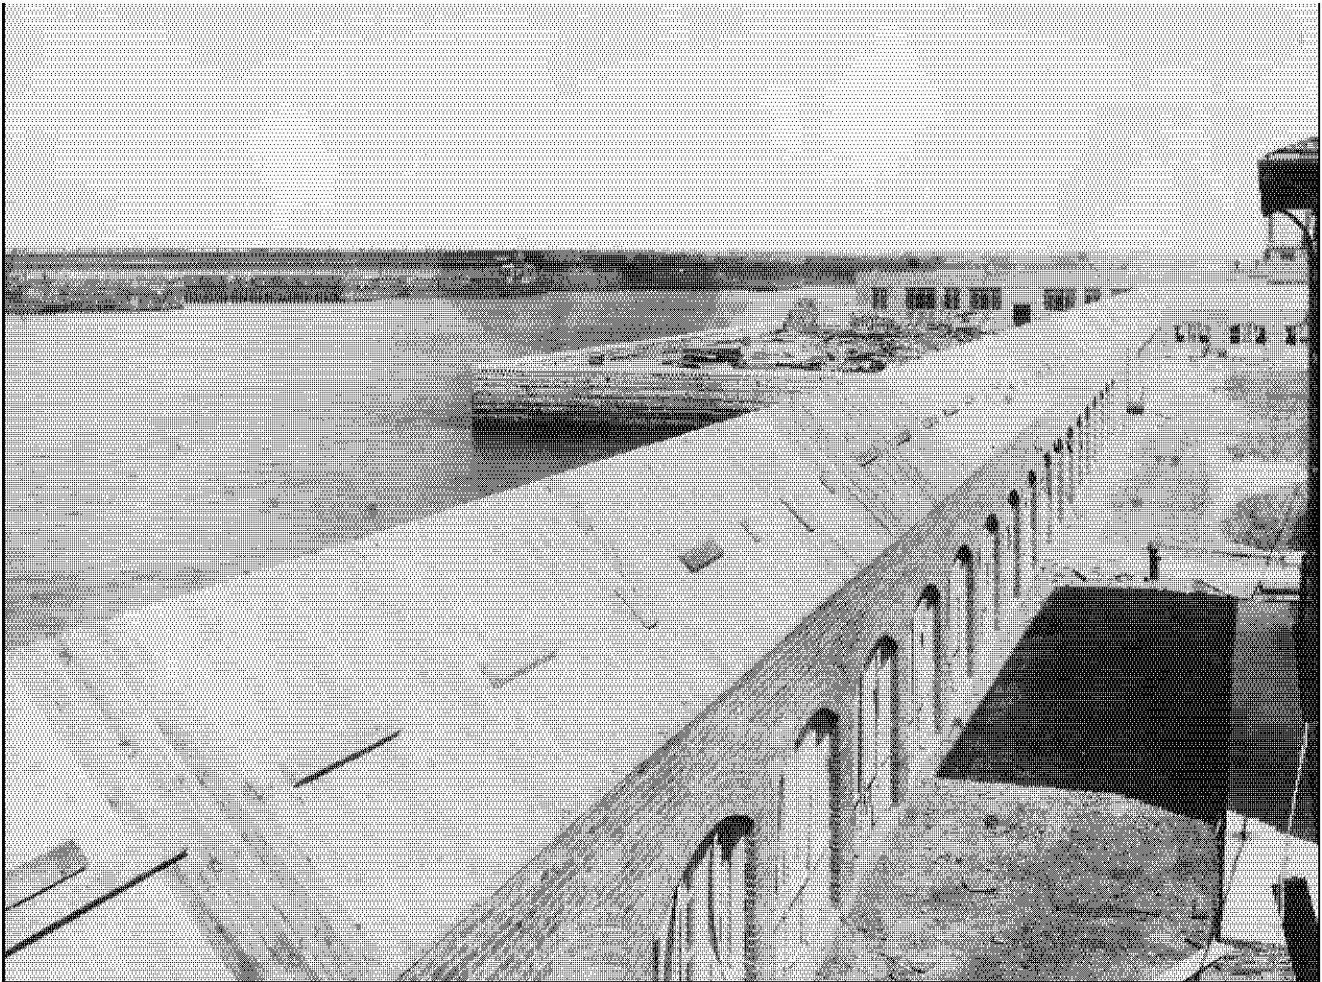
Figure 7: Passageway and New Immigration Building, 26 August 1935,  
Source: Record Group 121-BCP – Records of the Public Building Service,  
Photographs of the Construction of Federal Buildings, 1885-1954,  
Still Picture Branch, National Archives and Records Administration, College Park, Maryland

Connecting to the pavilions at the north and south end of the long corridor are additional connecting corridors. The north section is a curved, one-story red brick structure connected with the Main Immigration building on Island 1. It was built in 1934-1935 as a replacement for an older wood corridor. The south corridor is a long straight structure that parallels the west edge of Island 2 and Island 3. Known as Passageway C8C, it connects the Ferry and New Immigration buildings with the hospital complexes on Island 2 and Island 3. This perimeter corridor dates from 1934-1935 when it was built to replace a ca. 1918-1919 covered wood corridor in the same location. (Figures 7&8) The existing corridor contains a mechanical space for pipes.
